# Manhole Inspection Summary

Manhole # S35EE\_052MH

Insp Date: **3/5/07 11:31 AM**

**Location** Address: **1228 CALVERT ST**

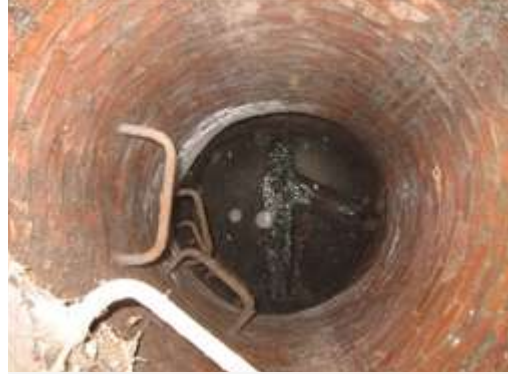
Top View

**Bench** ☒ Exists Material: **Brick** ☐ Parged ☒ **Debris** (not Condition related)

**Steps** Count: **8** Missing: **0** ☒ **Corroded**

Corroded steps. Bench debris.

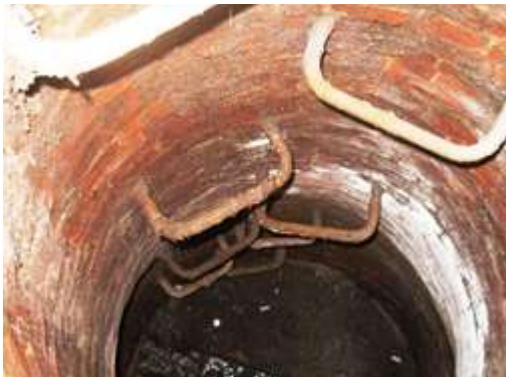
Defect

Infiltration: ☐ None ☐ Joint ☐ Cracks ☐ Mortar ☐ Roots ☒ **Wall**

Infiltration: ☐ None ☐ Joint ☐ Cracks ☐ Mortar ☒ **Roots** ☒ **Wall**

Corbel and Barrel infiltration.

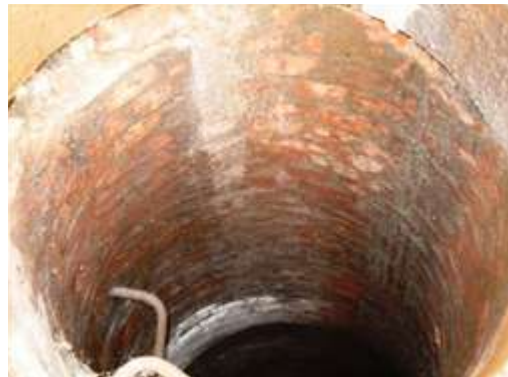
Defect

**Frame** Offset: **3** (in.) Condition: ☐ Sound ☐ Cracked ☒ **Leaks**

Condition: ☐ Sound ☐ Cracked ☐ Root Intrusion ☒ **Loose Brick** ☒ **Deteriorated**

Infiltration: ☐ None ☒ **Joint** ☐ Cracks ☒ **Mortar** ☐ Roots ☐ Wall

Frame leaks. Adjustment deterioration, loose brick and infiltration - other side.

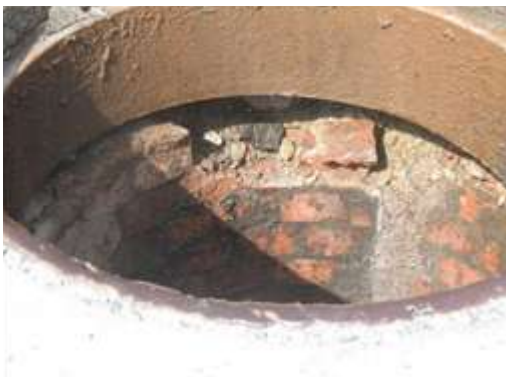
Defect

Frame leaks. Adjustment deterioration, loose brick and infiltration.

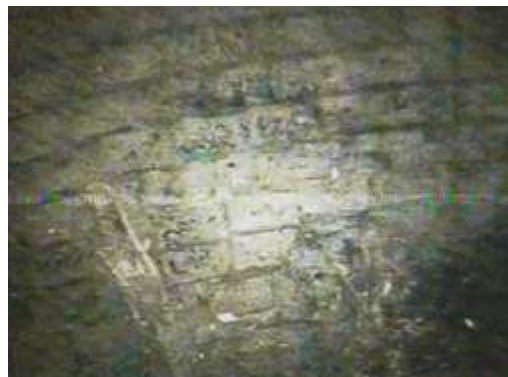
Defect

Condition: ☐ Sound ☐ Cracked ☒ **Root Intrusion** ☐ Loose Brick ☐ Deteriorated

Barrel root intrusion and infiltration.

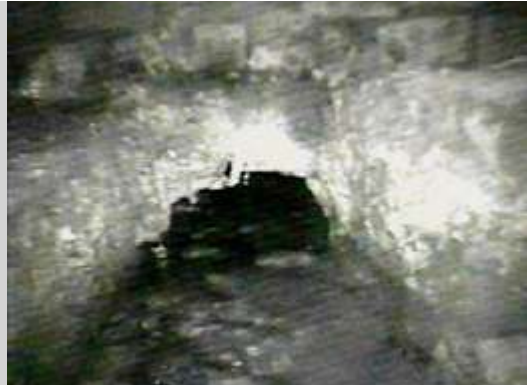
### 8 in. Circular Gravity Sewer Pipe Out @ 12 O'Clock

Deposits: ☐ None ☒ **Mud** ☐ Sludge ☒ **Debris** ☒ **Grease**

Silt Depth: **2** (in.) Deposits Extent: **Light**

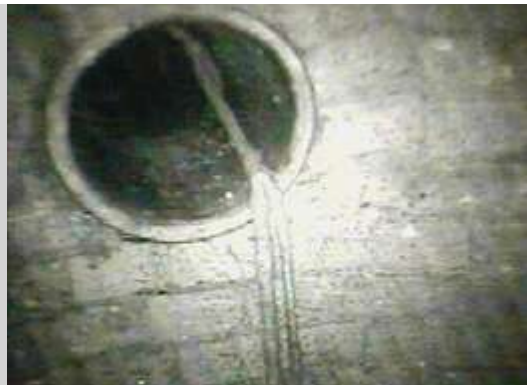
### 8 in. Circular Gravity Sewer Pipe In @ 3 O'Clock

Root intrusion.

Deposits: ☐ None ☒ **Mud** ☐ Sludge ☒ **Debris** ☒ **Grease**

Infiltration: **Evidence** Pipe Seal Cond: **Roots**
